SandGuard™ ESP Case Study

SUMMARY:

Forum Energy Technologies partnered with a major O&G operator in the Permian Basin to provide technology which eliminate ESP failures as well as issues with efficiency caused by sand fallback. This study is ongoing, and already several of the ESPs have had their run life increased by as much as 800%, resulting in a potential cost savings of millions of dollars.

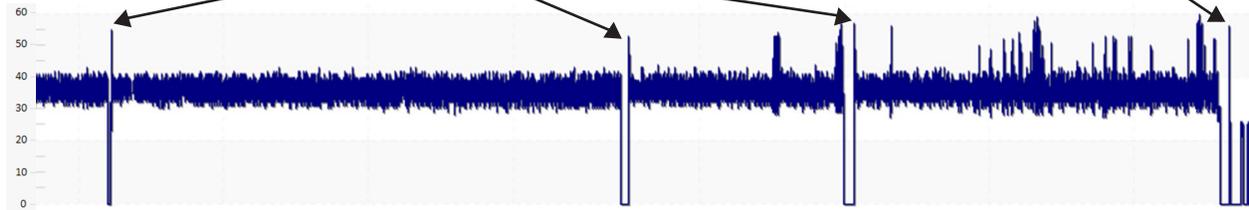
BEFORE SANDGUARD

Hard starts - jumped to 55-60 amps on start on 3 restarts.

Hard start leading to failure - broken shaft.

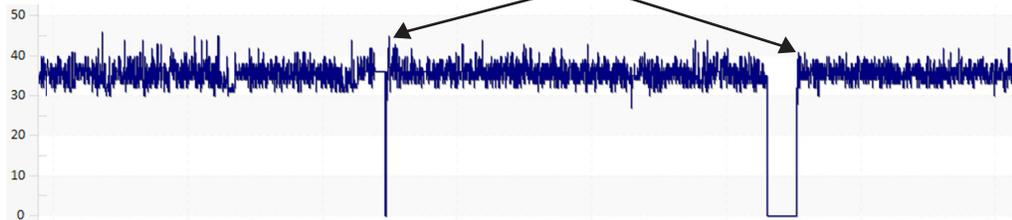
AFTER SANDGUARD

Two starts with amps staying in standard operating range (40 & 45 max amps during restart).
