Drum Crush

A Historical Perspective and Basic Prevention Tips

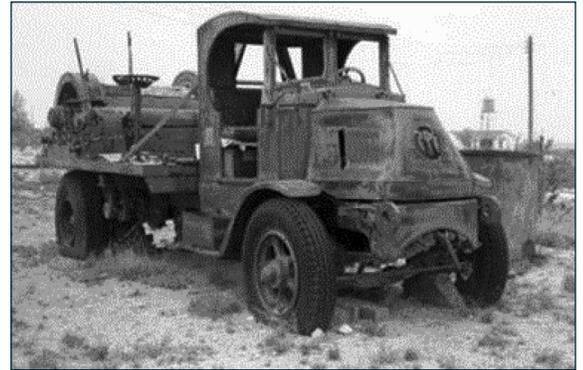
In the early 1950s, the first double armored cables featured rubber-insulated conductors and were installed directly from the factory shipping reel to the truck drum. A 2x4 was commonly wedged under the flange of the shipping reel to establish extra tension. Major service companies developed a “dead man” setup where the turnaround sheave was attached to a 500-pound weight. The payoff brakes were adjusted continuously to keep the weight off the ground. This weight was later increased to 1,000 pounds.

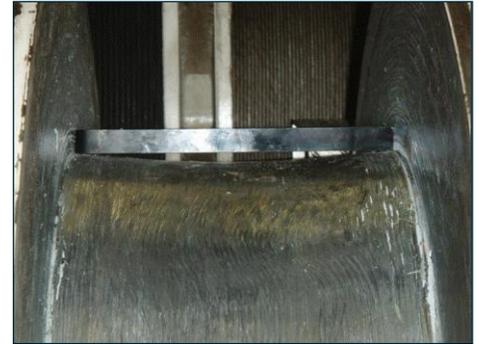
To establish a double break pattern, the cable makes the first half wrap against the flange. Then, a filler of one-half cable diameter is placed against the drum flange to move the cable over for the last half wrap. A filler is also required for the last half revolution of the final wrap on the drum. For the full cable to spool properly, the breaks must form a straight line across the drum, and the cable must move from the bed layer to the second layer at a point exactly opposite the cable’s entry point on the starting flange.

When a covering layer is positioned back over a lower layer, the wraps of the covering layer fall in the grooves between the lower layer wraps. The diameter of the spooled cable fitting in the grooves increases by only 0.87 of a cable diameter.

At the crossover point, the spooled diameter, in theory, increases by a full cable diameter. In practice, however, the cable gets “smashed” at the crossover so the diameter is not a full cable diameter.

On the second and subsequent layers, the breaks fall on top of the breaks of the underlying layer, causing a diameter buildup. If this diameter buildup is just at one point — as with the single break — then the drum full of cable is dynamically out of balance. In deep-hole operations, a drum spooled with a single break will severely shake the truck at high line speeds, while a double break pattern prevents this problem.
